UConn Voting Technology Research Center

Engineering Notes:

Follow up on the problem encountered in the Town of Wilton using new non-volatile memory cards

February 7, 2013

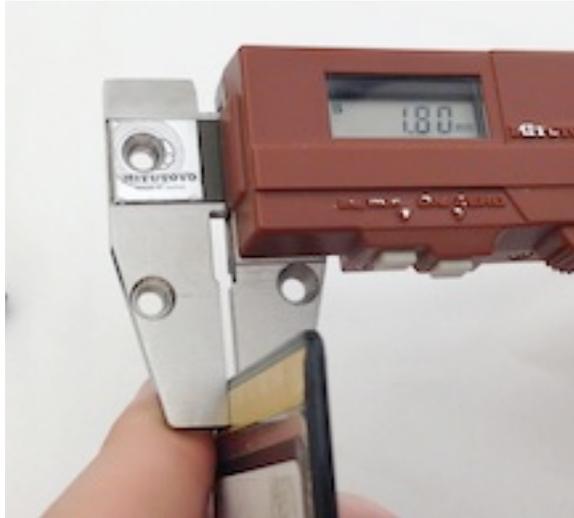
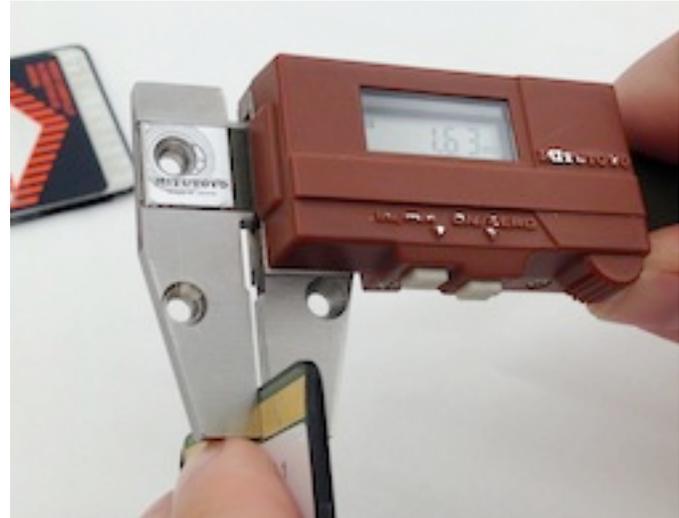
Card Thickness Measurement at the Connector Area

The measurements show that the new card is about 10% thinner in this area as compared to the original card: 1.63 mm for the new card vs. 1.80 mm for the original card.

Original battery-powered card

New nonvolatile card

The thickness of the connector area is essential for the AV-OS J40 connector to make a solid contact with all 40 pins of the memory cards when they are inserted into the AV-OS tabulator.

The cross-section of the pin on the J40 connector is shown in the figure. The card presses down on the pin when the card is inserted. This indicates that the connections are tighter when using the thicker original card.

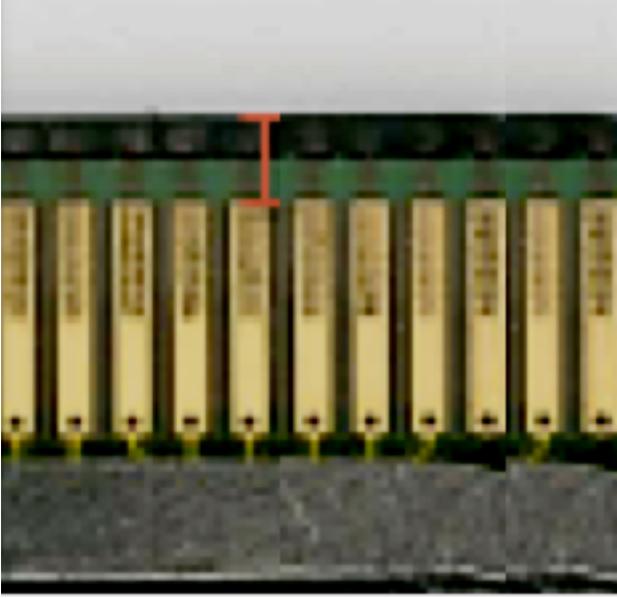
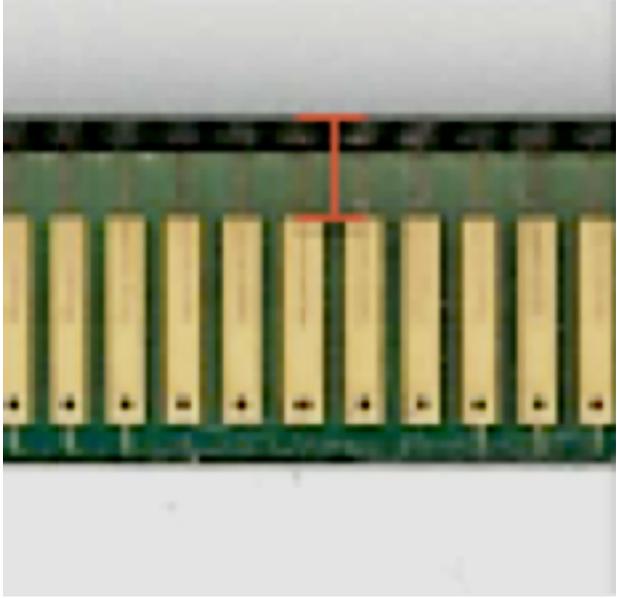
This distance for the original card is ~~11~~ 44px as compared to the ~~13~~ 54px for the new card. This is about a ~~15~~ 20% difference. At 600dpi the difference of ~~2~~ 10px = ~~2~~ 10 * 25.4 / 600 = ~~0.085~~ 0.423 mm.

Original battery-powered card (41 44px)	New non-volatile card (43 54px)
Pin Edge Distance from the Card Edge

Measurements were also taken of the distance from the card edge to the edge of the connector pin. To measure this distance we used a flatbed optical scanner (Ricoh Aficio MP 6001) at 600 dpi. We measured the distance in pixels (px) using an image editor.

While we note this difference, it is not clear whether this is a contributing factor to the observed problem.
