Determining the Causes of AccuVote Optical Scan Voting Terminal Memory Card Failures*

Tigran Antonyan Nicolas Nicolaou Alexander A. Shvartsman Therese Smith
Computer Science & Engineering, University of Connecticut, Storrs, CT 06269, USA

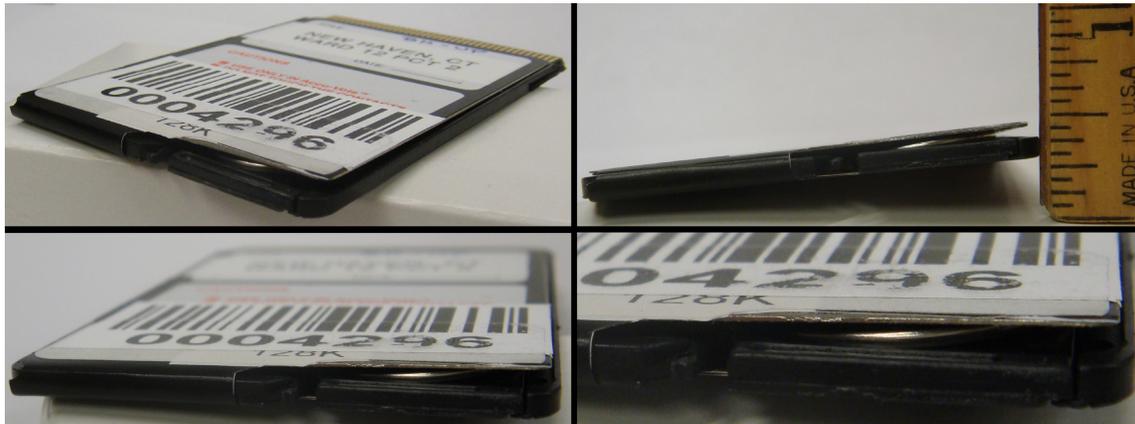
The four cards (12% of the total) that failed appeared to have hardware problems or showed signs of physical damage. Two of the cards showed abnormal behavior, in particular, one card appeared to have an internal short circuit as it was draining the battery to 0V within a very short time after installation. Two other cards were in a physically damaged condition. Out of the four cards, three were physically damaged (e.g., as in Figure 1).

Figure 1: Memory Card – enclosure is apart from frame

Recall that for physical security, identification and sealing purposes, the memory cards have tamper-evident, self-adhesive label that also covers the battery compartment. The card is built in layers, with the card circuit positioned within a frame that is in turn sandwiched between two covers. We noticed that if the paper label is damaged, absent or does not wrap around the card, then such cards may start coming apart, in particular exposing the battery compartment (one can see the battery in the lower right corner of the card, see Figure 1). Poll workers may not necessarily be aware of this damage. Cards in this condition can lose their data in the event of the battery disconnection during normal handling. It is likely that such cards may lose their data during normal handling and shipping.

In addition to renewing batteries, based on our observations election officials should inspect the cards for physical wear and damage. The visual inspection needs to focus on loose or damaged enclosures, and such cards must be replaced or repaired.

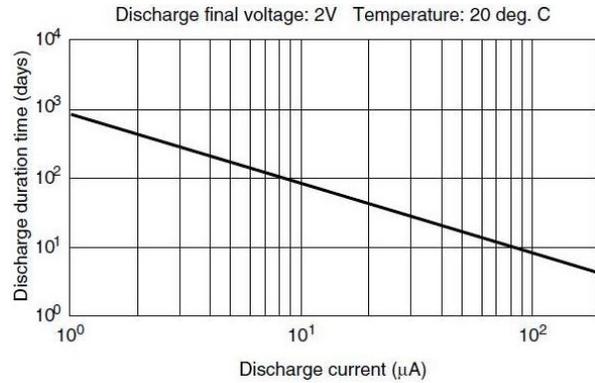
Figure 3: Significance of load upon battery for service lifetime

Using the Maxell datasheet [21] that provides information (shown in Figure 3) about depletion time as a function of load to support our extrapolation, we compute the anticipated depletion curve for the battery when the memory card is the electrical load. It can be seen on this plot that a current demand of $10\ \mu\text{A}$, obtained from a memory chip datasheet, corresponds to a service lifetime of approximately 90 days (12.9 weeks).

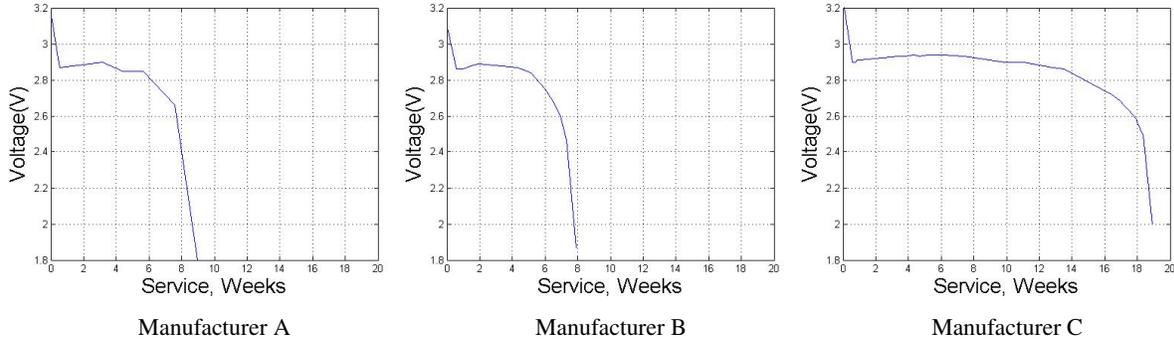
As seen in the plots of Figure 2 the watch battery depletion curve has a flat region followed by a *steeply dropping region*. As the reserve of stored energy in the battery is reduced, the voltage also tends to decline. We reiterate that there are good reasons (e.g., avoiding waste of energy) for designing batteries to maintain output voltage within a narrow region while the energy is being depleted. In particular, batteries have a design feature that holds the remaining voltage above a designed level until most of the stored energy has been used. This design feature has the purpose of delivering the energy stored in the battery in a manner efficient for its intended application. In other words, electronic circuits waste less energy if no excess voltage is delivered, and they can be expected to fail to function if insufficient voltage is applied. Thus, the minimum waste of energy is obtained when batteries deliver a constant voltage over their service life.

Figure 2: Depletion curve measurements upon batteries from three different manufacturers (scaled to $10 \mu\text{A}$).

Battery	Load	Time Interval above 2V
Manufacturer A	adjusted to 300 kOhms	8.6 weeks
Manufacturer B	adjusted to 300 kOhms	7.8 weeks
Manufacturer C	300 kOhms	18.9 weeks

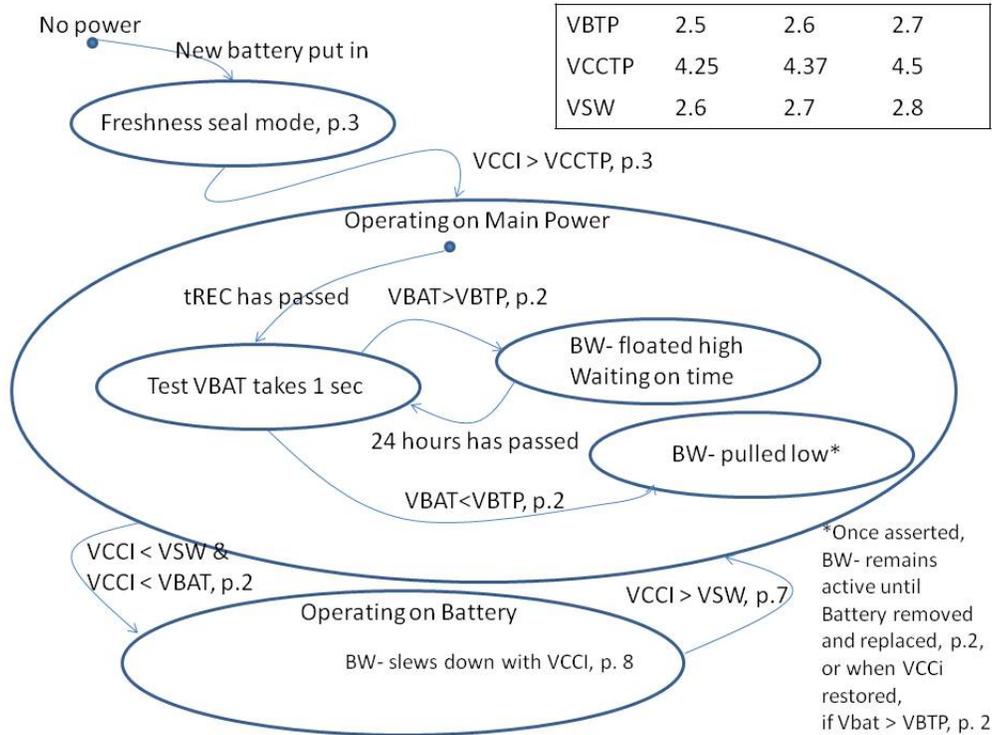
Figure 4 illustrates the finite state machine (FSM) of the operation of the DS1312 chip, using information obtained from the DS1312 datasheet [5]. It also presents a legend of the possible values, as a result of the variability in the manufacturing process, that the various thresholds may take. The chip has three responsibilities of which we describe two (the third function is write protection of the memory). The two relevant responsibilities are (as

Figure 4: Operation of DS1312.

We can conclude that the battery is checked in two cases: (i) startup (when the machine is turned on with the memory card already in it, or when the memory card is inserted while the machine is already on), or (ii) periodically while the machine is left on and 24 hours have passed from the last check. The threshold VBTP cannot be set higher than the voltage of a new battery, otherwise new batteries will immediately be declared to be at end of life. Therefore, the highest meaningful value of VBTP is the nominal voltage of the fresh battery, 3 volts. The lowest possible value of that threshold is the value needed by the memory circuits to retain data. Between these maximum (fresh battery voltage) and minimum (smallest according to RAM specification) voltages is the region within which a voltage threshold has a chance of being useful. In this region, higher values of threshold correspond to earlier warnings.

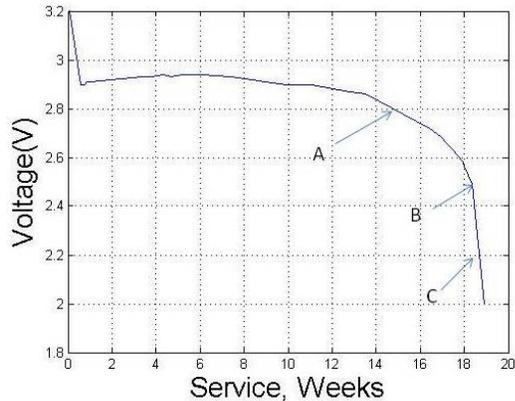
The steepness of the battery depletion curve, which is an intended design feature of the battery (see Section 4.1), causes the strong influence of these factors (current drawn, voltage threshold) upon the warning time. Figure 5 depicts the depletion curve of the battery and shows the warning time in weeks from 2.5V (point A) and 2.4V (point B) to 2.2V (point C) and 2V. The plot is scaled to correspond to 10 μ A of load. The shape of the curve differs between manufacturers, so the warning time depends upon the brand of the battery; nevertheless, the warning time is too short for all of the batteries we have investigated.

(A) Depending upon the brand of the battery, the output voltage of the battery can cross below 2.8V almost immediately in the life of the battery [21] or not until 12 days prior to end of life [9].
 (B) With a threshold setting of 2.5V, a warning time of 7 week with one brand of battery is obtained, and with another brand, 5 weeks.
 (C) 2V is the voltage specification for a possible SRAM chip, 2.2V specified so that a DS1312 chip would (by specification sheet) deliver 2V to the RAM. Using 2.2V shortens the warning time for a threshold of 2.5V from 7 weeks to 5 weeks, and from 5 weeks to less than 4 weeks.

Figure 5: Estimating warning time
